Navajo Abandoned Uranium Mine

Site Screen Report

Paul Huskie No. 20 AUM Site

January 2011

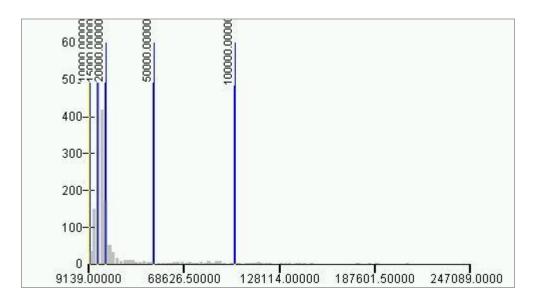
Describe any other radiological measurements:

A total of 1,648 gamma radiation measurements were collected from the mine site, ranging from 9,139 cpm to 247,089 cpm. The measurements collected at an isolated pile of petrified wood were found at a maximum level of approximately 250,000 cpm. The measurements are represented in Figures 1 and 2.

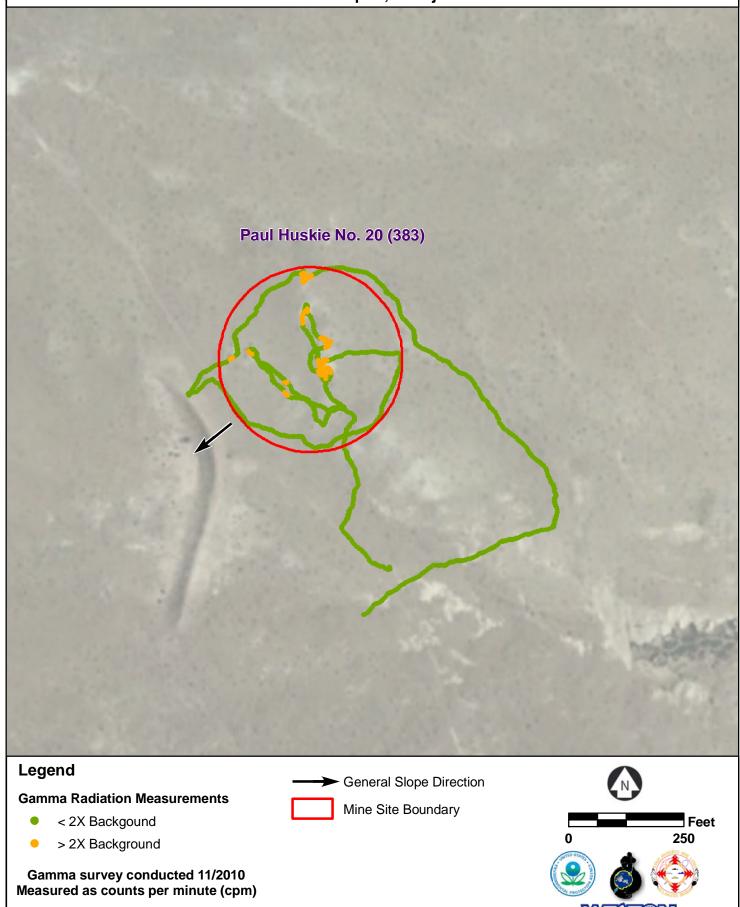
Figure 1 - Gamma Radiation Measurements, Above Two Times Background
Paul Huskie No. 20 (383)
Cameron Chapter, Navajo Nation

Average background 14,140 cpm

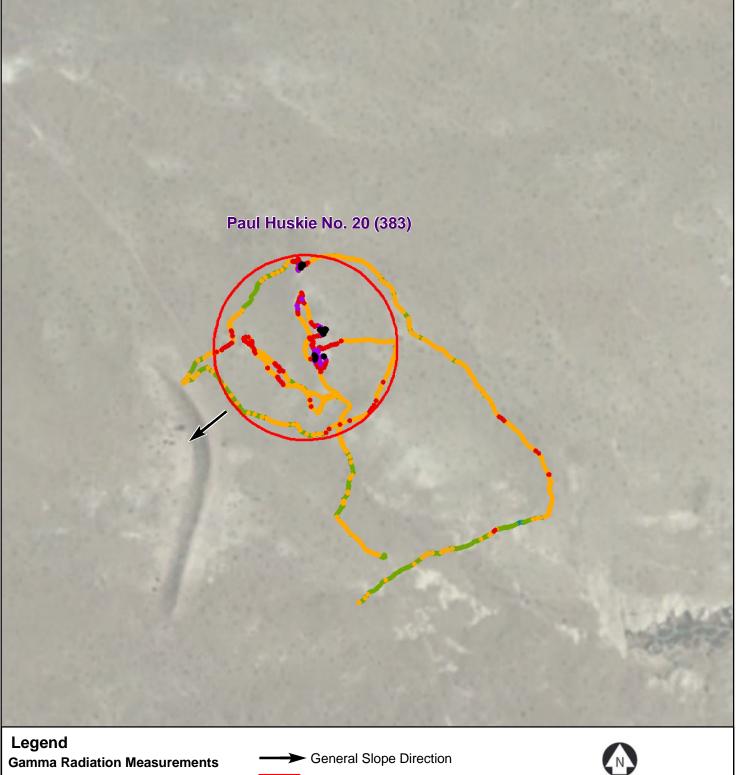
Figure 2 - Gamma Radiation Measurements Paul Huskie No. 20 (383) Cameron Chapter, Navajo Nation

Gamma survey conducted 11/2010 Measured as counts per minute (cpm)

Average background 14,140 cpm
